## Significant Incident Report No. 276

**Subject:** Fall from height after failure of retractable type lanyard

**Date:** 28 May 2019

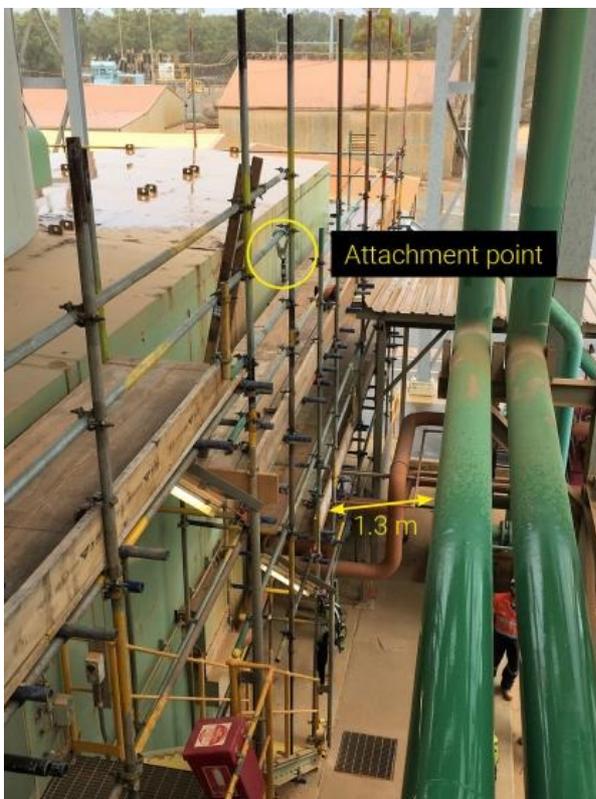
In June 2018, a scaffolder fell while crossing a void 5.7 metres above the ground. The scaffolder was wearing a fall arrest harness with a retractable type lanyard connected to a horizontal guardrail of a scaffold platform. When stepping 1.3 metres laterally to access a pipe support structure, the inertia reel mechanism of the lanyard engaged, impacting the scaffolder's balance. This caused the scaffolder to fall backwards through the void and swing against the scaffold structure. The webbing on the retractable lanyard then sheared below the shock (energy) absorber component. The scaffolder fell approximately four metres, landing on a staircase and dislocating his shoulder.

Left: Void between scaffold and pipe support structure. Right: Fall location and height.

- Higher level risk mitigation measures (e.g a stairway) were not in use.
- The fall arrest equipment was not used in a way to reduce, so far as is practicable, the possibility of injury to the user.
- The anchor point selection was incorrect for the application and outside the maximum of 30° offset recommended in AS/NZS 1891.4:2009, Part 5.1.2.
- The lanyard integrity was compromised at the connection between the inertia reel and the shock absorber with the webbing material worn and/or damaged.
- The scaffolder's lateral swing (the pendulum effect) extended the fall distance, likely exceeding free fall limits, before the lanyard took up the load.

- Identifying if there are alternative and safer methods of conducting the task.
- Identifying the hazards, assess and control all risks that may arise for all activities involving the use of fall arrest equipment.

- Confirming workers conducting work at heights with fall arrest equipment are adequately instructed, trained, assessed and supervised.
- Using fall arrest equipment in accordance with AS/NZS 1891.4:2009 and the manufacturer's recommendations, including a total fall distance calculation to ensure a residual safety clearance is maintained.

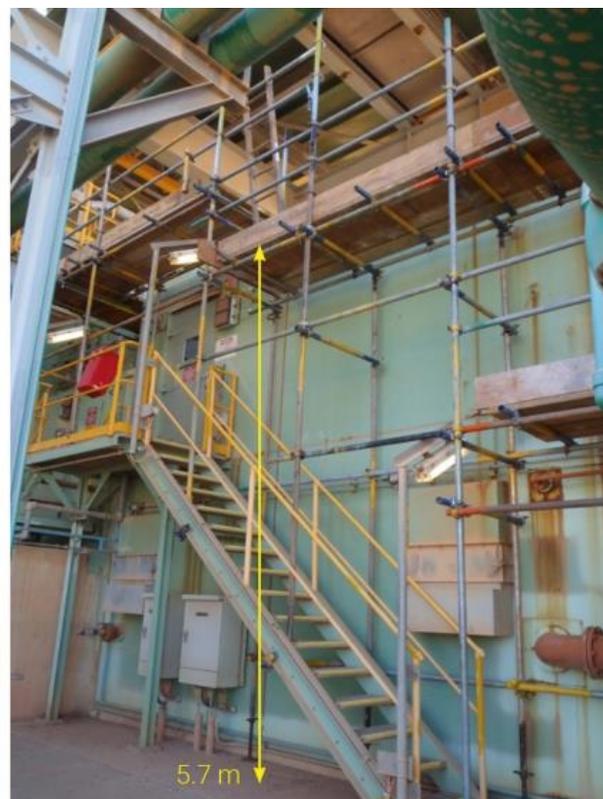
- The scaffolder lost his balance while crossing a void.
- The lanyard failed before deploying the shock absorber.
