Significant Incident Report No. 274

Subject: Structural failure of fixed conveyor stacker

Date: 18 March 2019

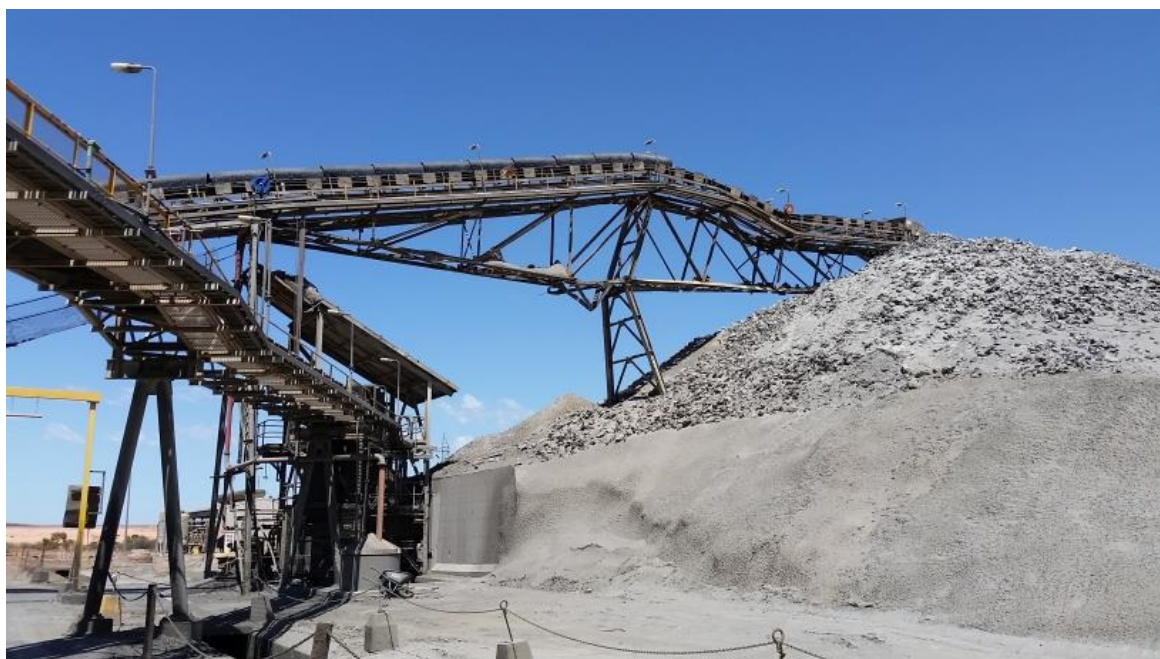
Collapsed stacker resting on stockpile and showing product build-up on bottom chord.

- The structural integrity of critical members had deteriorated substantially due to corrosion.

- Inadequate inspection and maintenance of the structural members.
- Failure to remove product build-up on structural members.
- Failure to provide access to inspect all parts of the structure.

- Ensure all practicable efforts are made to prevent:
 - build-up of product or other material on structures
 - exposure of the structure to corrosive materials.

- Prior to integrity inspection of plant and structure, ensure all product is removed from members and joints and the area is cleaned to allow for inspection and identification of all types of defects.

- Ensure access is provided to all parts of the structure for viewing and testing as required by the competent person(s) undertaking the inspections. This may require elevating work platforms (EWPs), scaffolding, confined space permits, isolation of moving equipment and appropriate PPE.
